TransWarp GS GAL and Oscillator Upgrade Guide

From: ReactiveMicro.com

Revised: 9-28-10

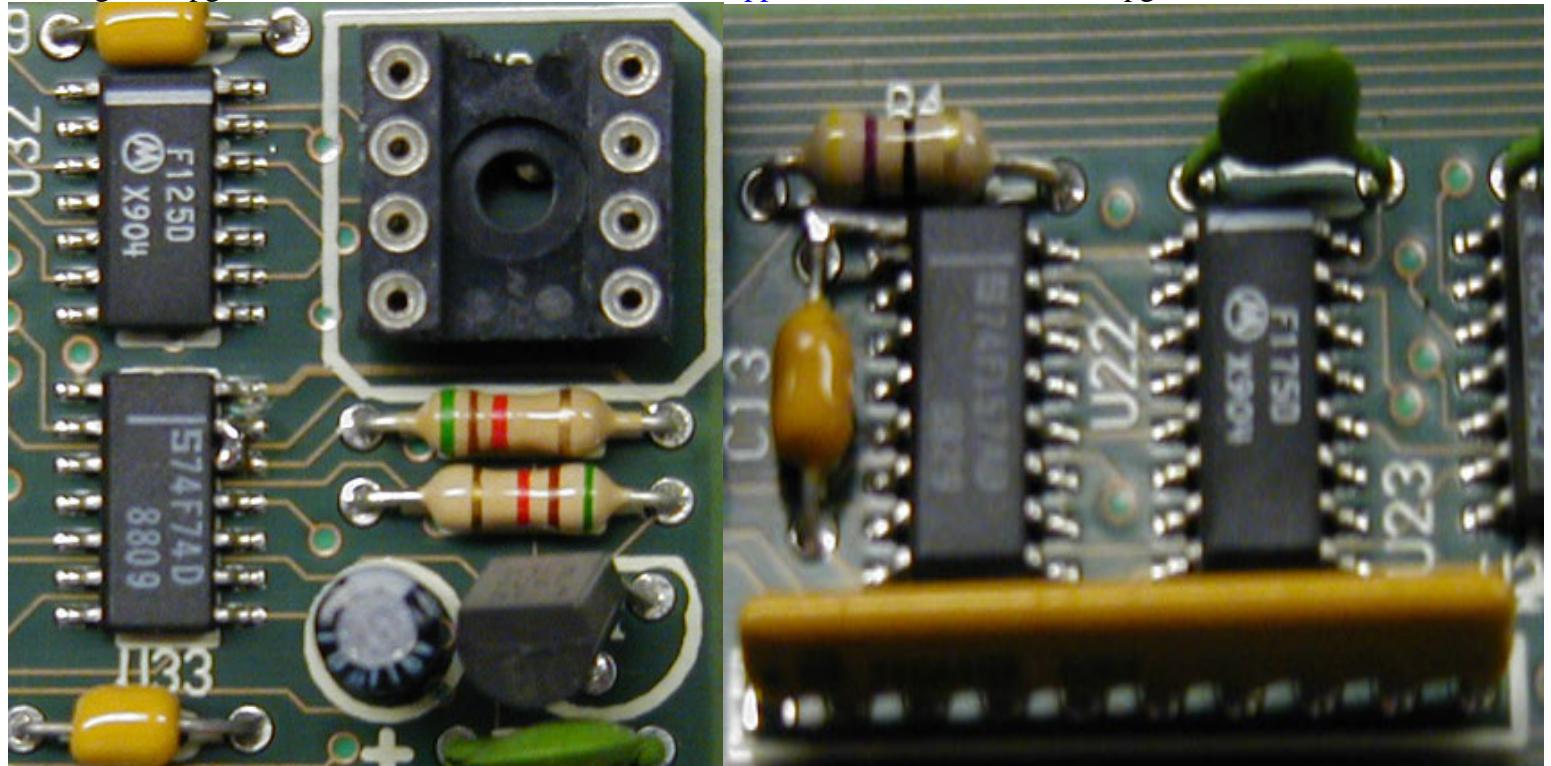
To reach up to 18.75 MHz there are also some mods that need to be done to a couple ICs on the board. The ICs are located on the face of the TransWarp. Just left of the Oscillator at U33, and just right of the 40 Pin Test Header on the top of the board at U22. U33 needs the trace cut between Pins 13 and 14, and then solder together Pins 12 and 13. U22 needs Pin 1 lifted from the PCB, and then solder Pin 1 to the Cap at C13. See pics below for examples. We will be offering this upgrade service in our [Store](#) soon. Email [Support](#) in the mean time if an upgrade is desired.
