TransWarp GS GAL and Oscillator Upgrade Guide

From: ReactiveMicro.com

Revised: 9-28-10

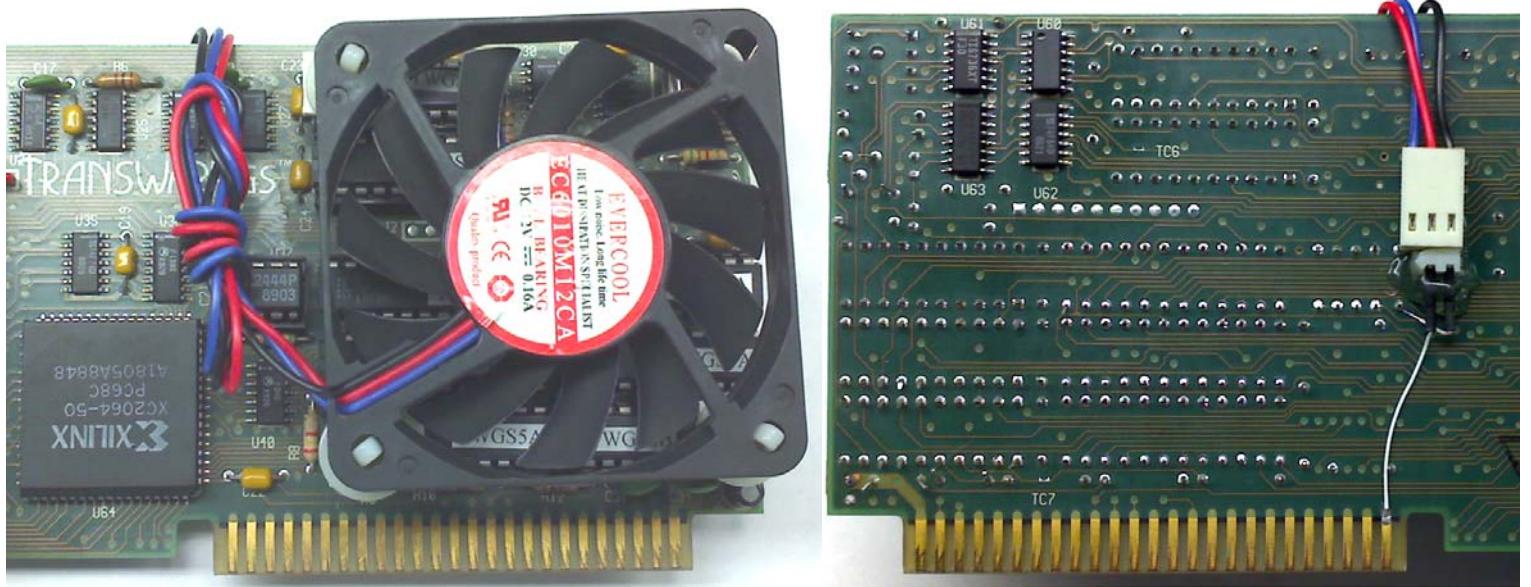
We have found that heat can be an issue with the TransWarp GS. We recommend placing a fan blowing directly on the GALs and Oscillator of the TransWarp GS. This can help resolve the TransWarp GS crashing or locking up. It won't help with speed, but it will help make the board more stable. Any additional cooling, like the IIgs System Saver, is also recommended. Below is an example of how we mount the Fan on the TransWarp GS.
